WING LEADING EDGE FUEL TANK IMPACT TESTS

National Aviation Facilities Experimental Center

Federal Aviation Administration

Report No. FAA-RD-72-83

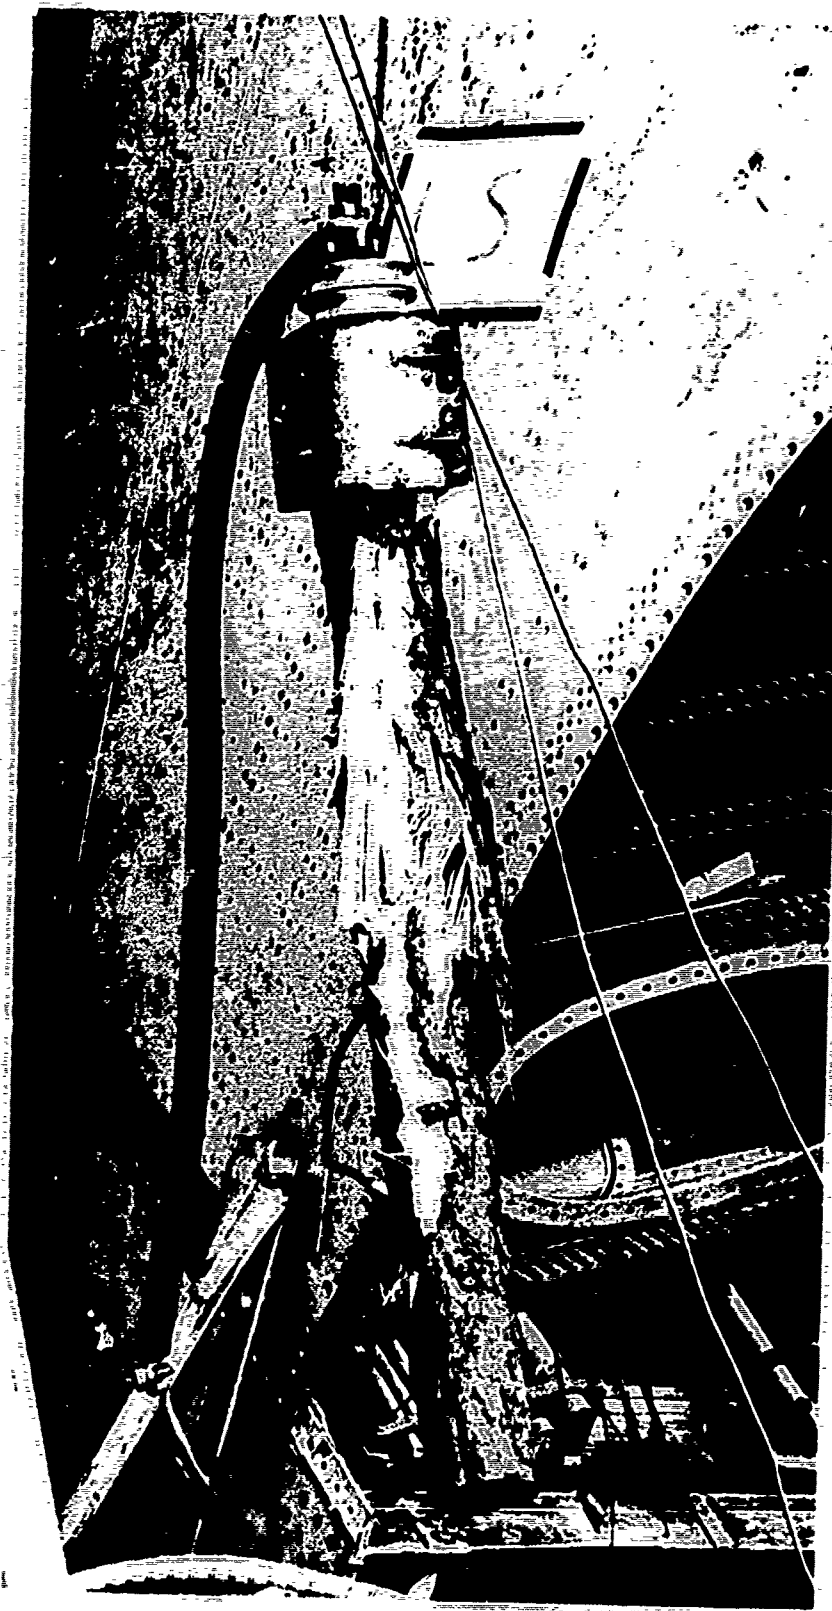
FIGURE 1. LOG FAILURE - TEST 2

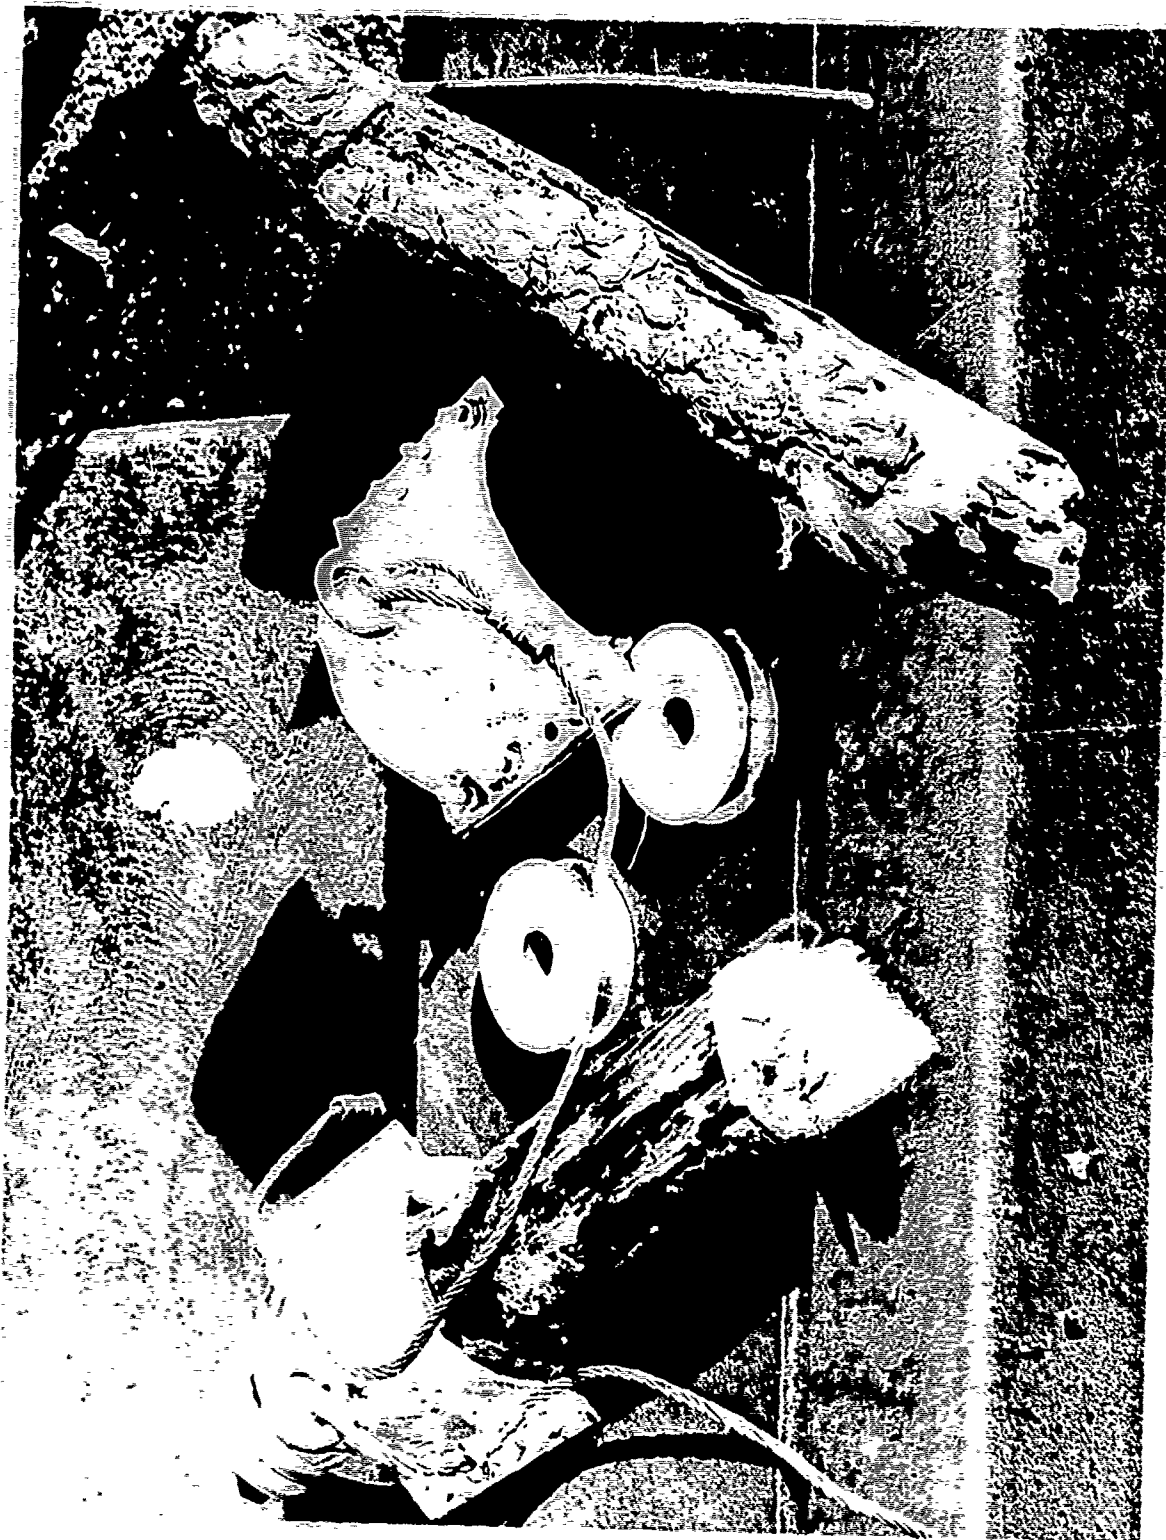
FIGURE 2. LOG FAILURE - TEST 4

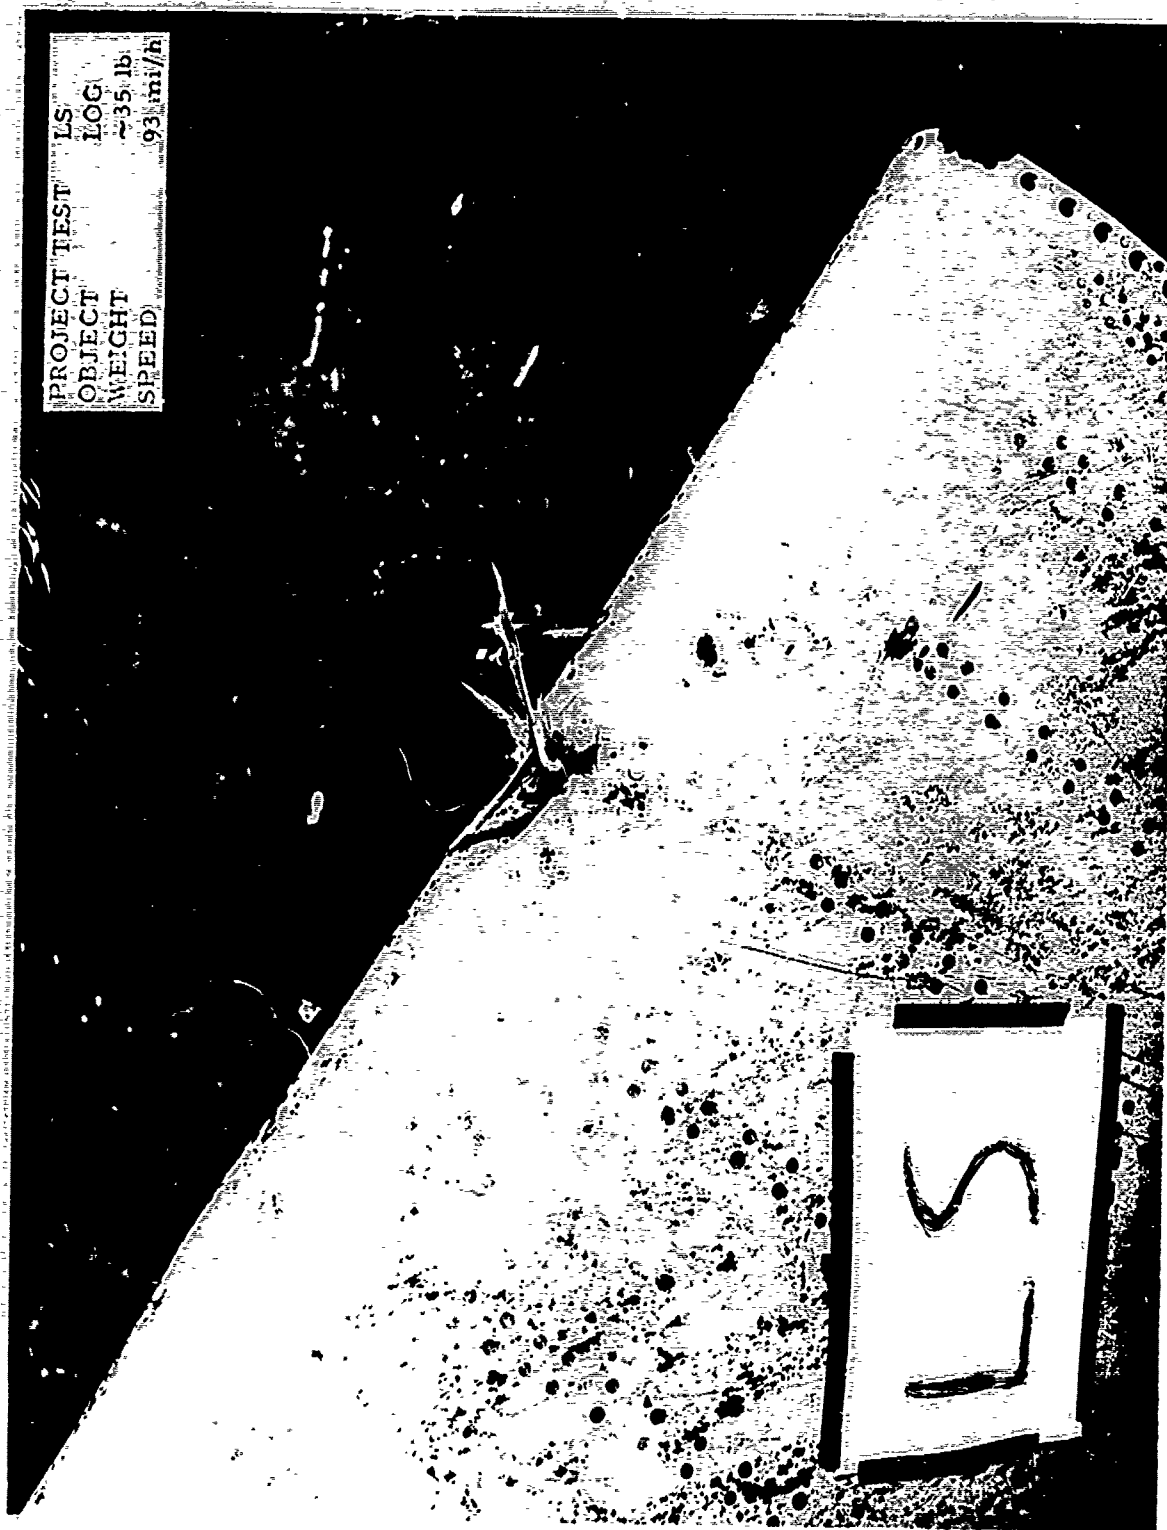
FIGURE 7. DAMAGE TO WING - TEST 2, 93.0 MI/H - LOG

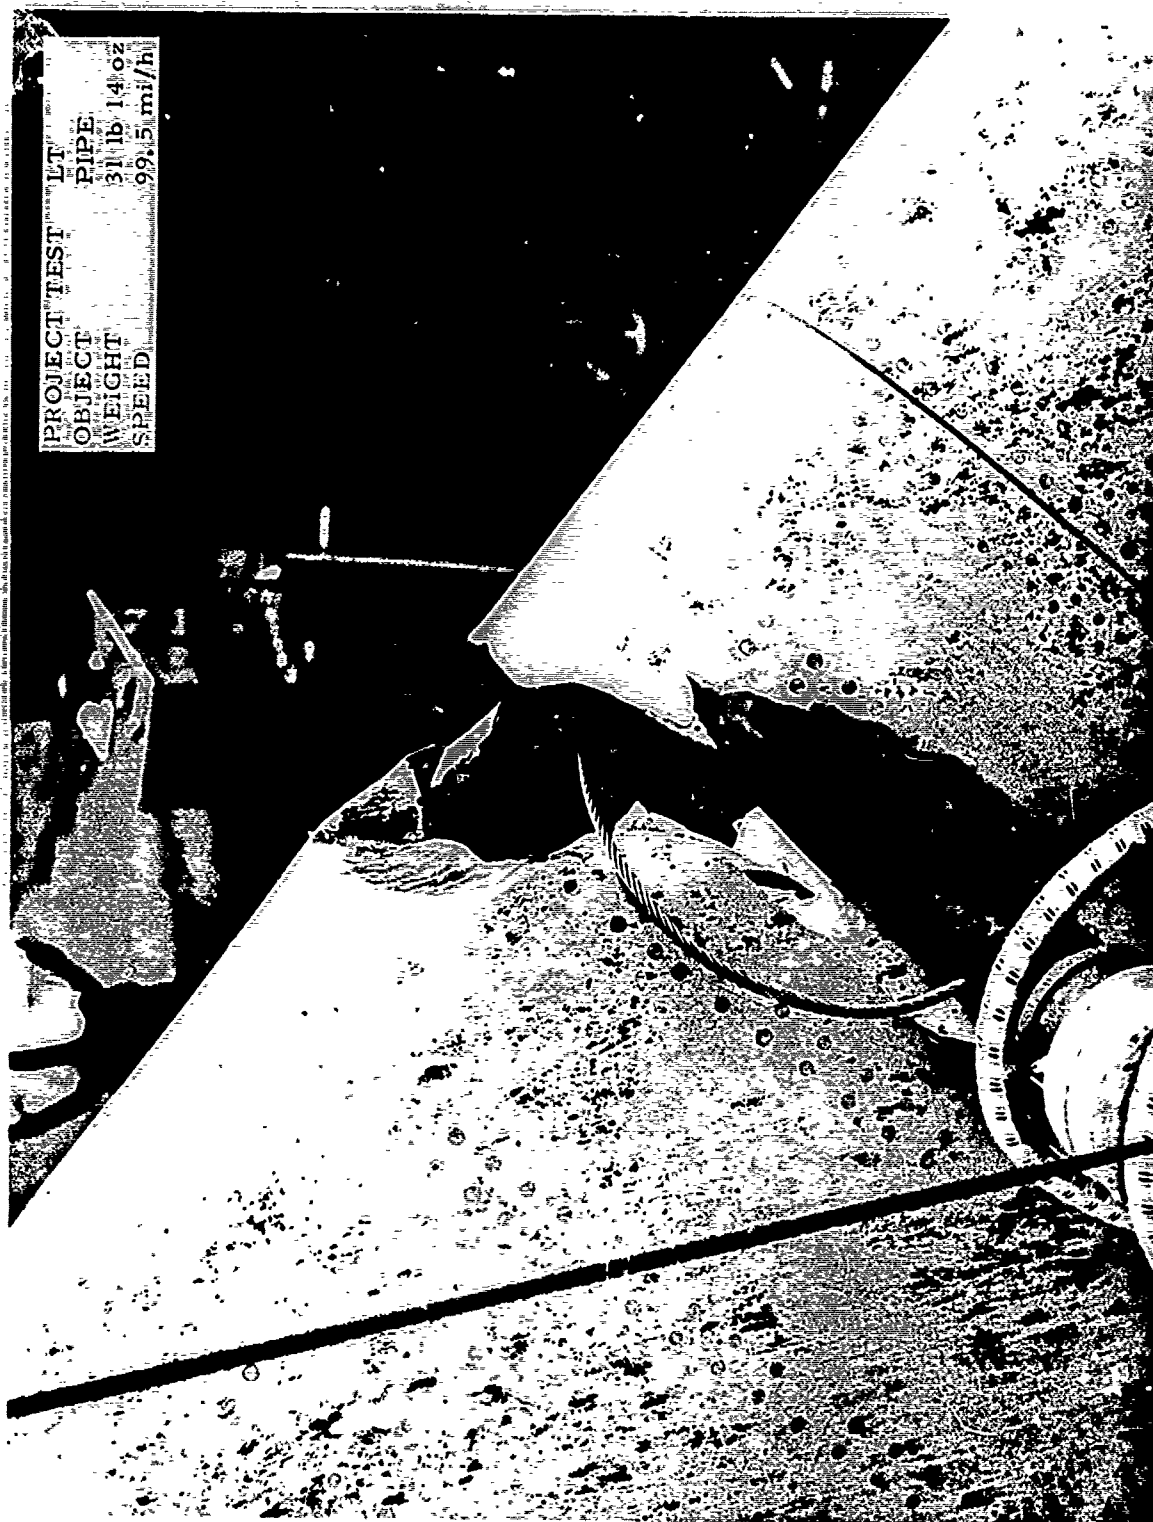
FIGURE 8: DAMAGE TO WING - TEST 3, 99.5 MI/H - PIPE

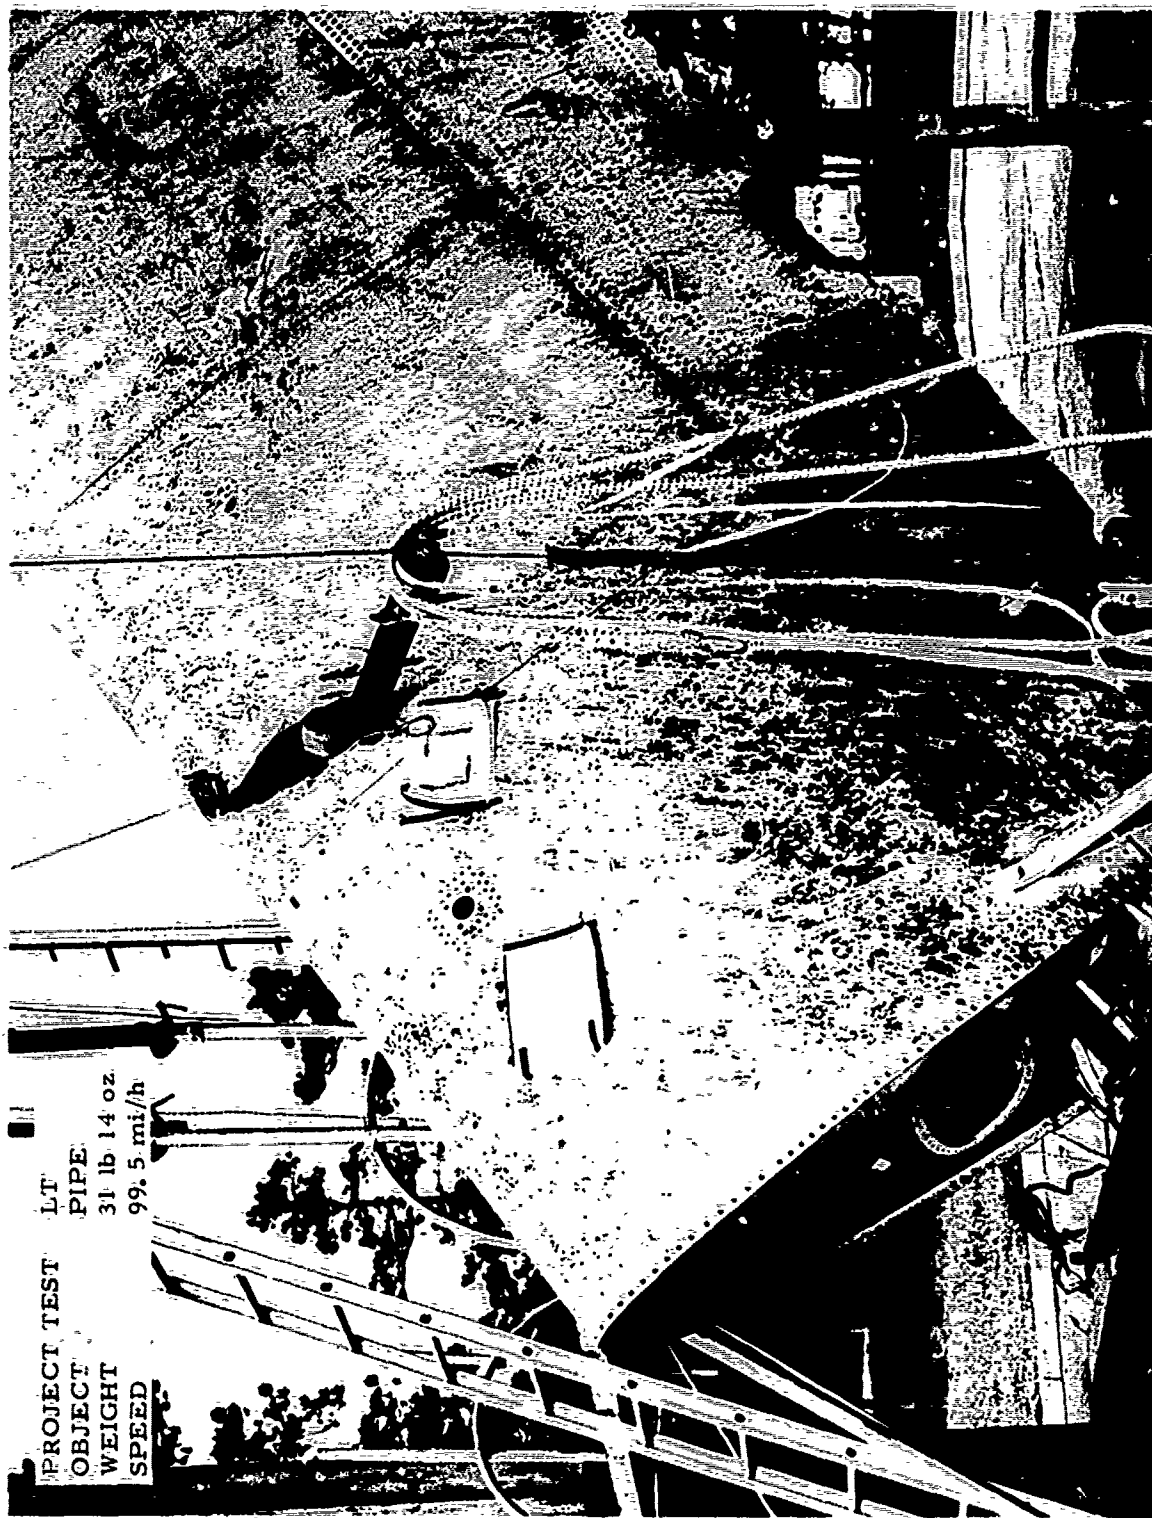
FIGURE 9. DAMAGE TO WING - TEST 3, 99.5 MI/H - PIPE

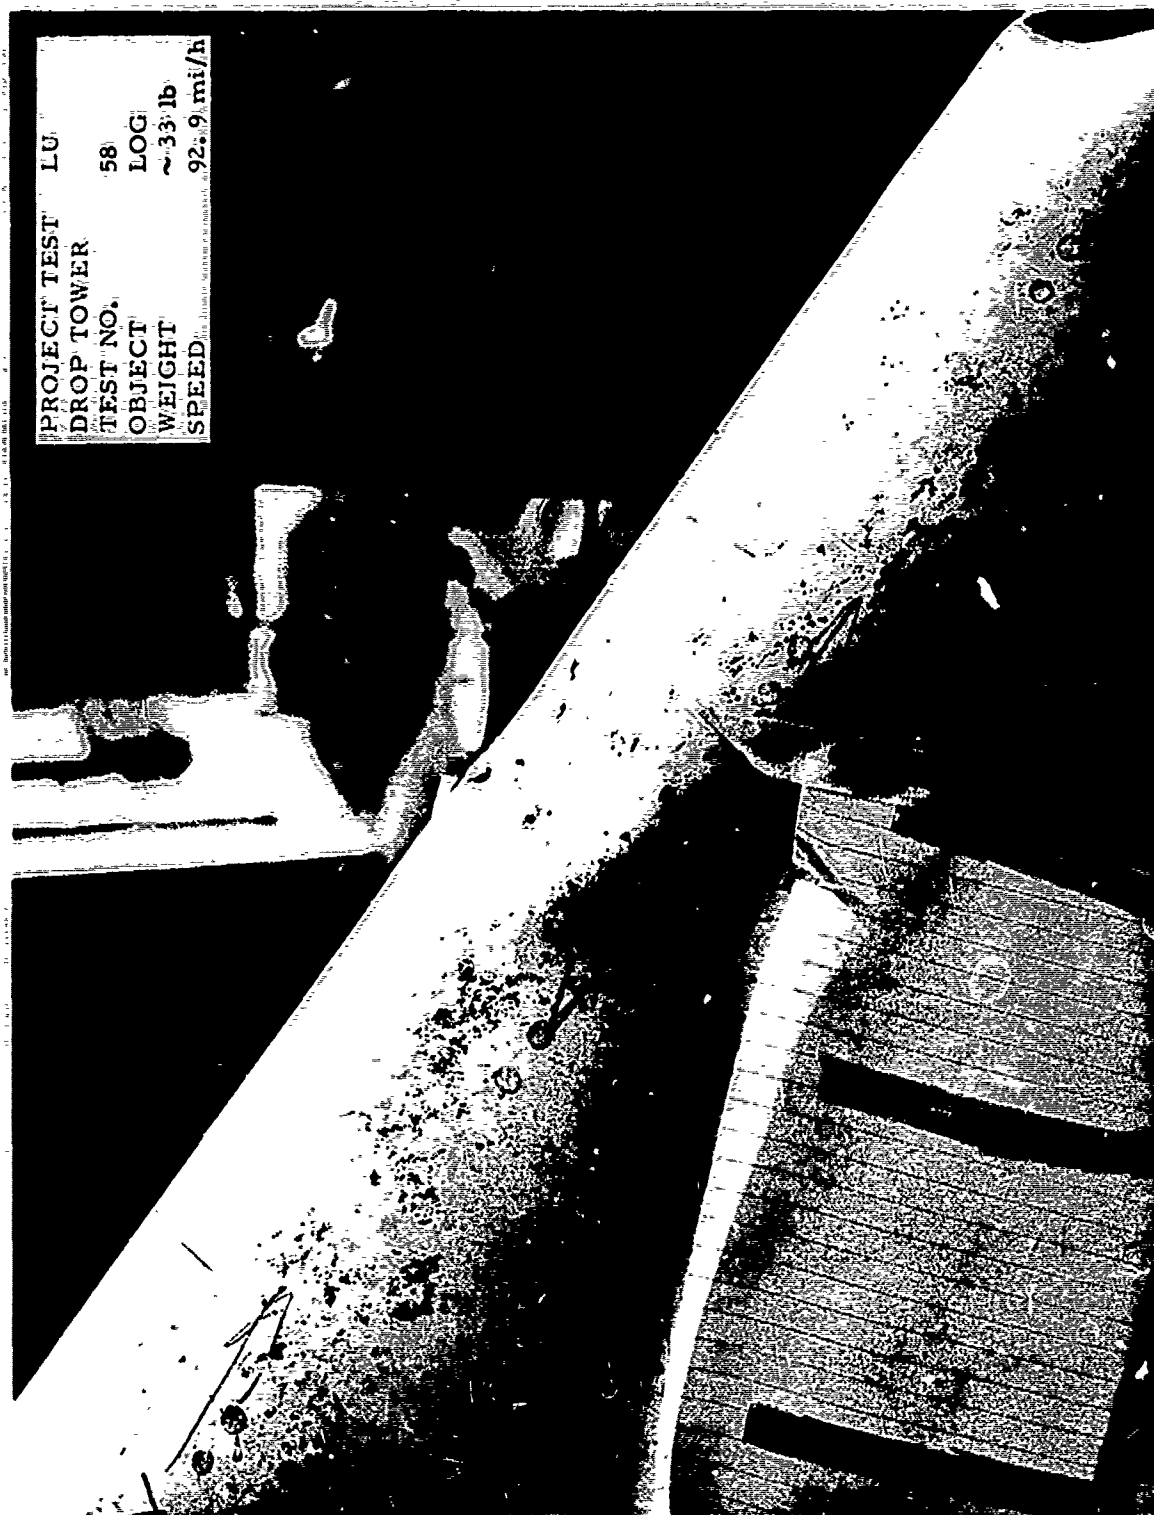
FIGURE 10. DAMAGE TO WING - TEST 4, 92.9 MI/H - LOG

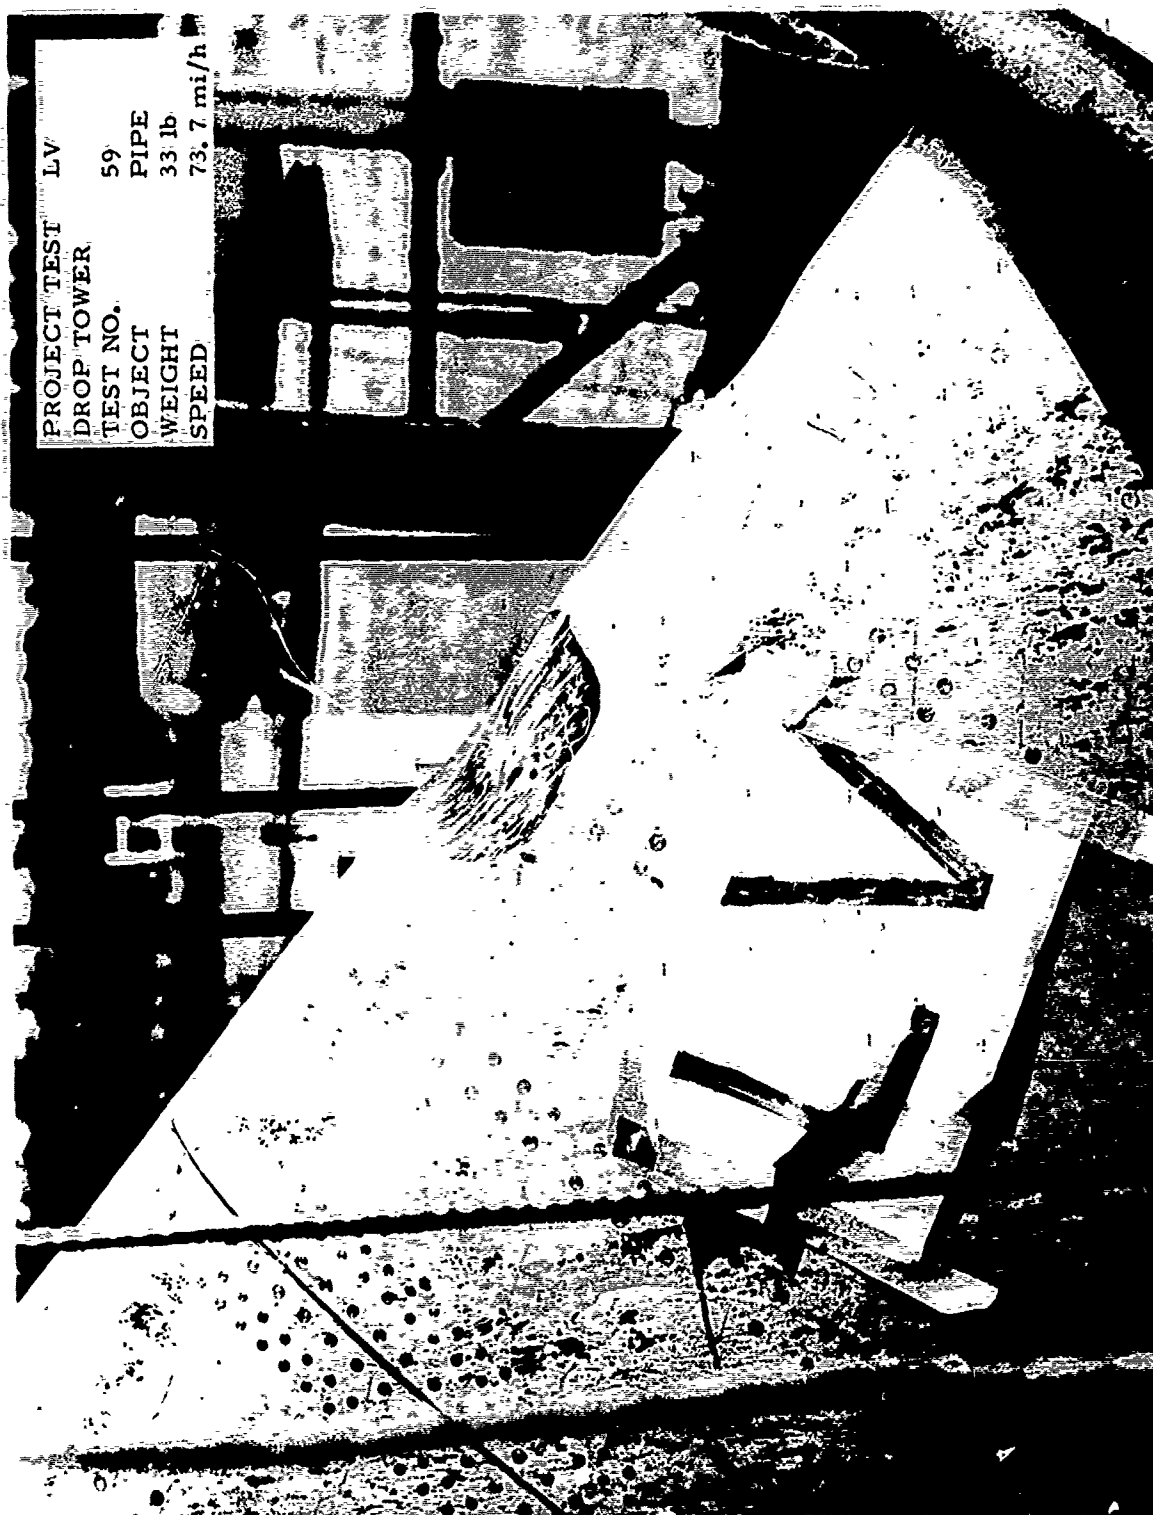
FIGURE 11. "DAMAGE TO WING" - TEST 5, 73.7 MI/H - PIPE

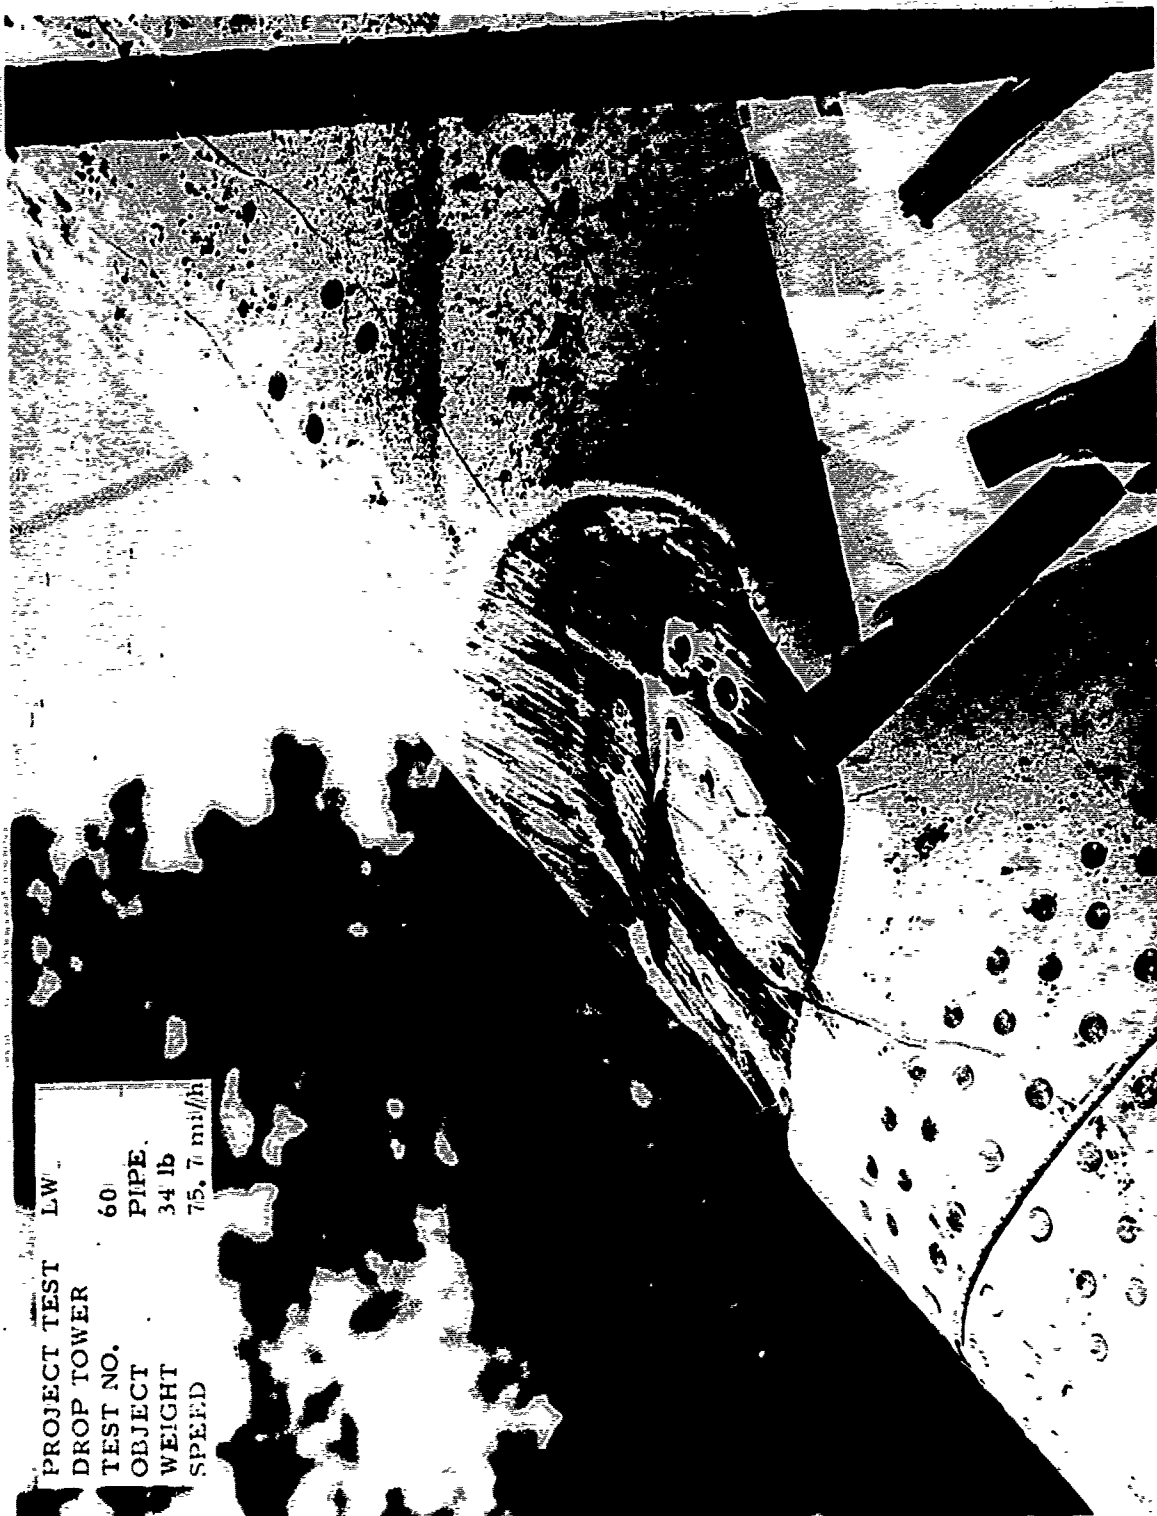
PROJECT TEST	LW
DROP TOWER	60
TEST NO.	PIPE
OBJECT	34 lb
WEIGHT	75.7 mi/h
SPEED

FIGURE 12. DAMAGE TO WING - TEST 6, 75.7 MI/H - PIPE

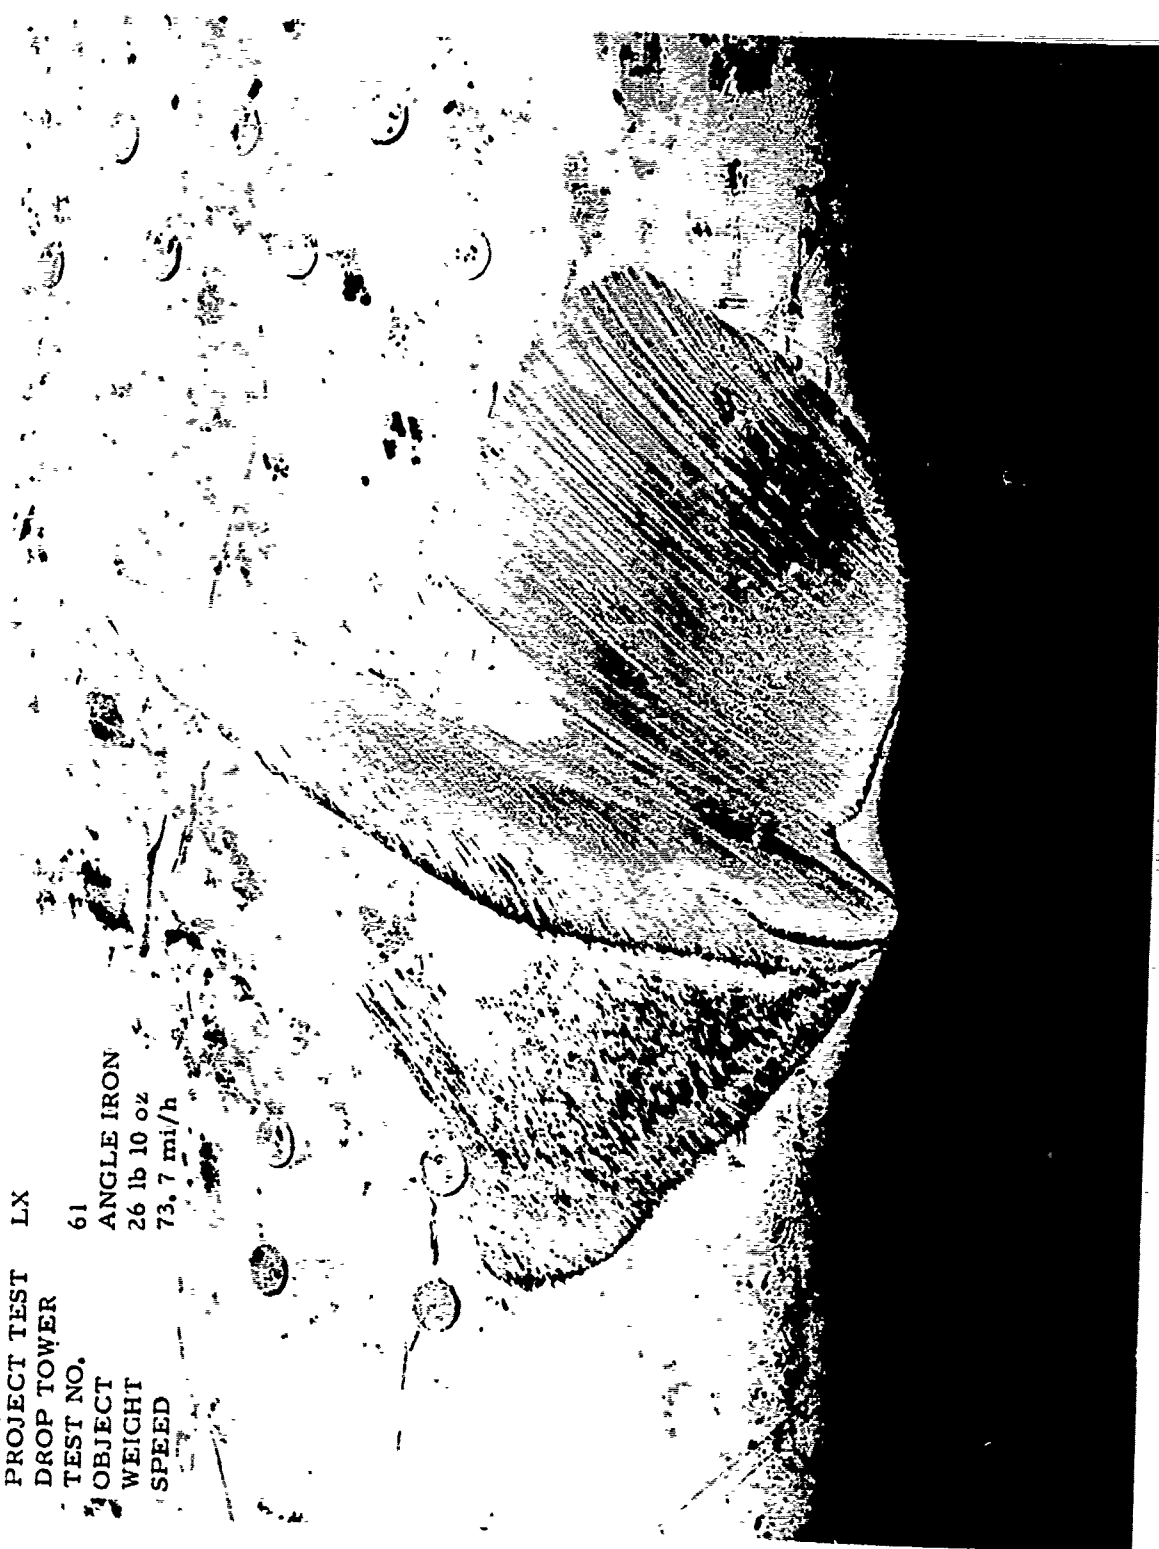
PROJECT TEST LX
DROP TOWER
TEST NO. 61
OBJECT ANGLE IRON
WEIGHT 26 lb 10 oz
SPEED 73.7 mi/h

FIGURE 13. DAMAGE TO WING - TEST 7, 73.7 MI/H - ANGLE IRON

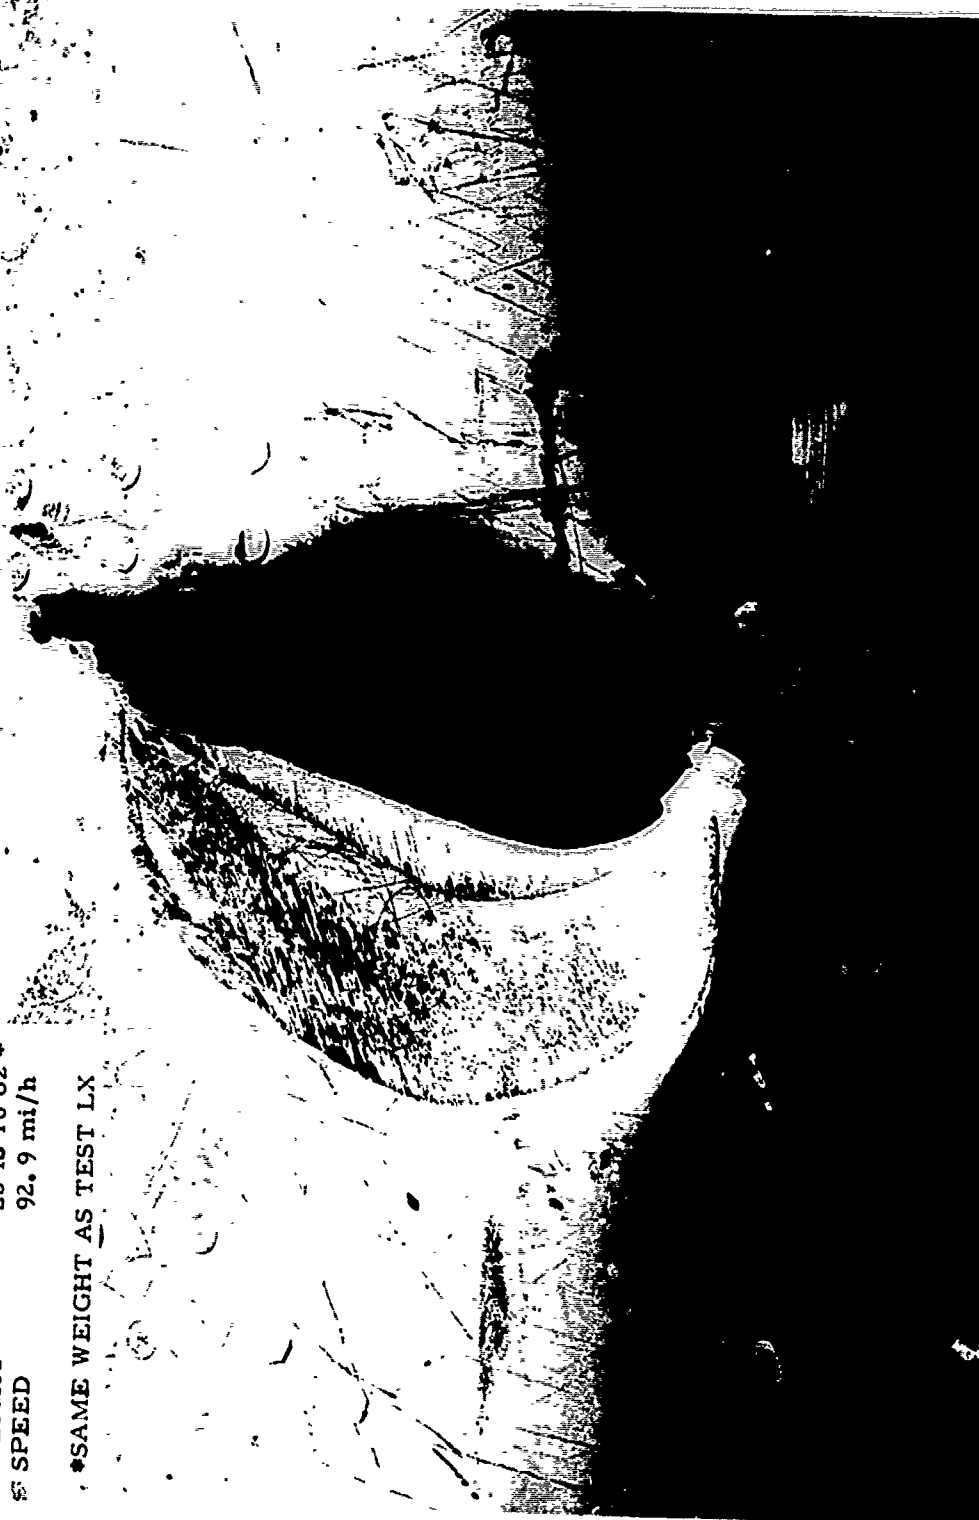
FIGURE 14. DAMAGE TO WING - TEST 8, 92.9 MI/H - ANGLE IRON

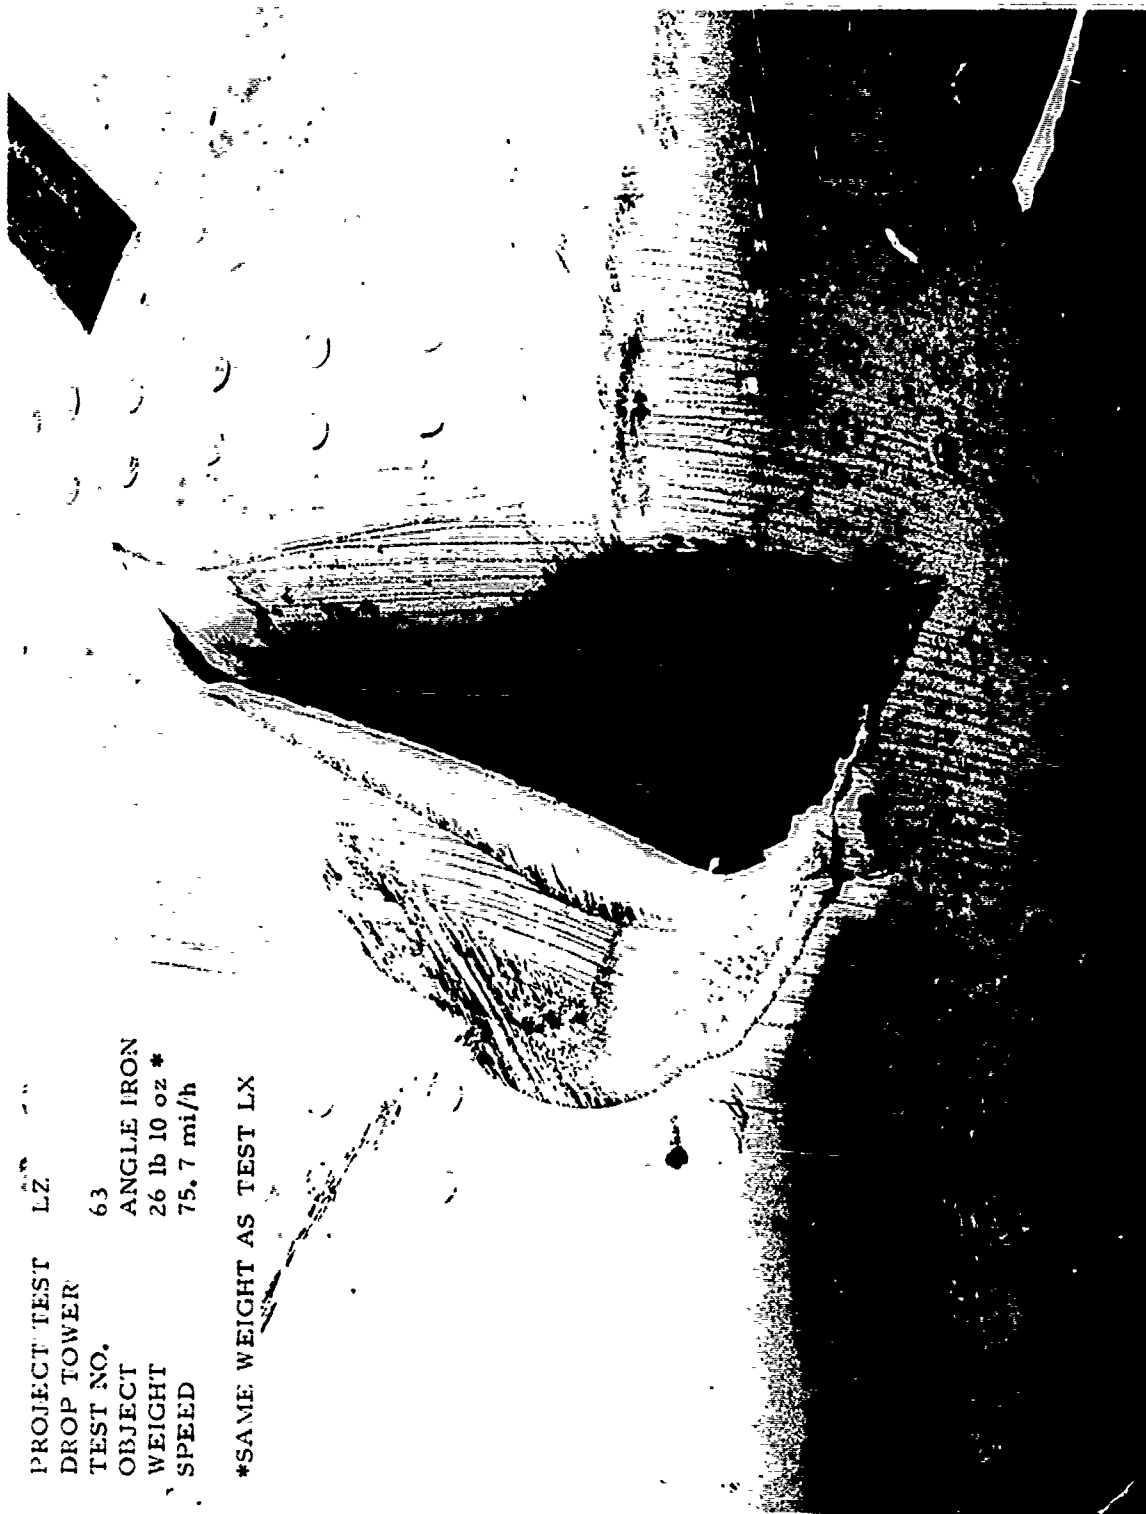
FIGURE 15. DAMAGE TO WING - TEST 9, 75.7 MI/H - ANGLE IRON

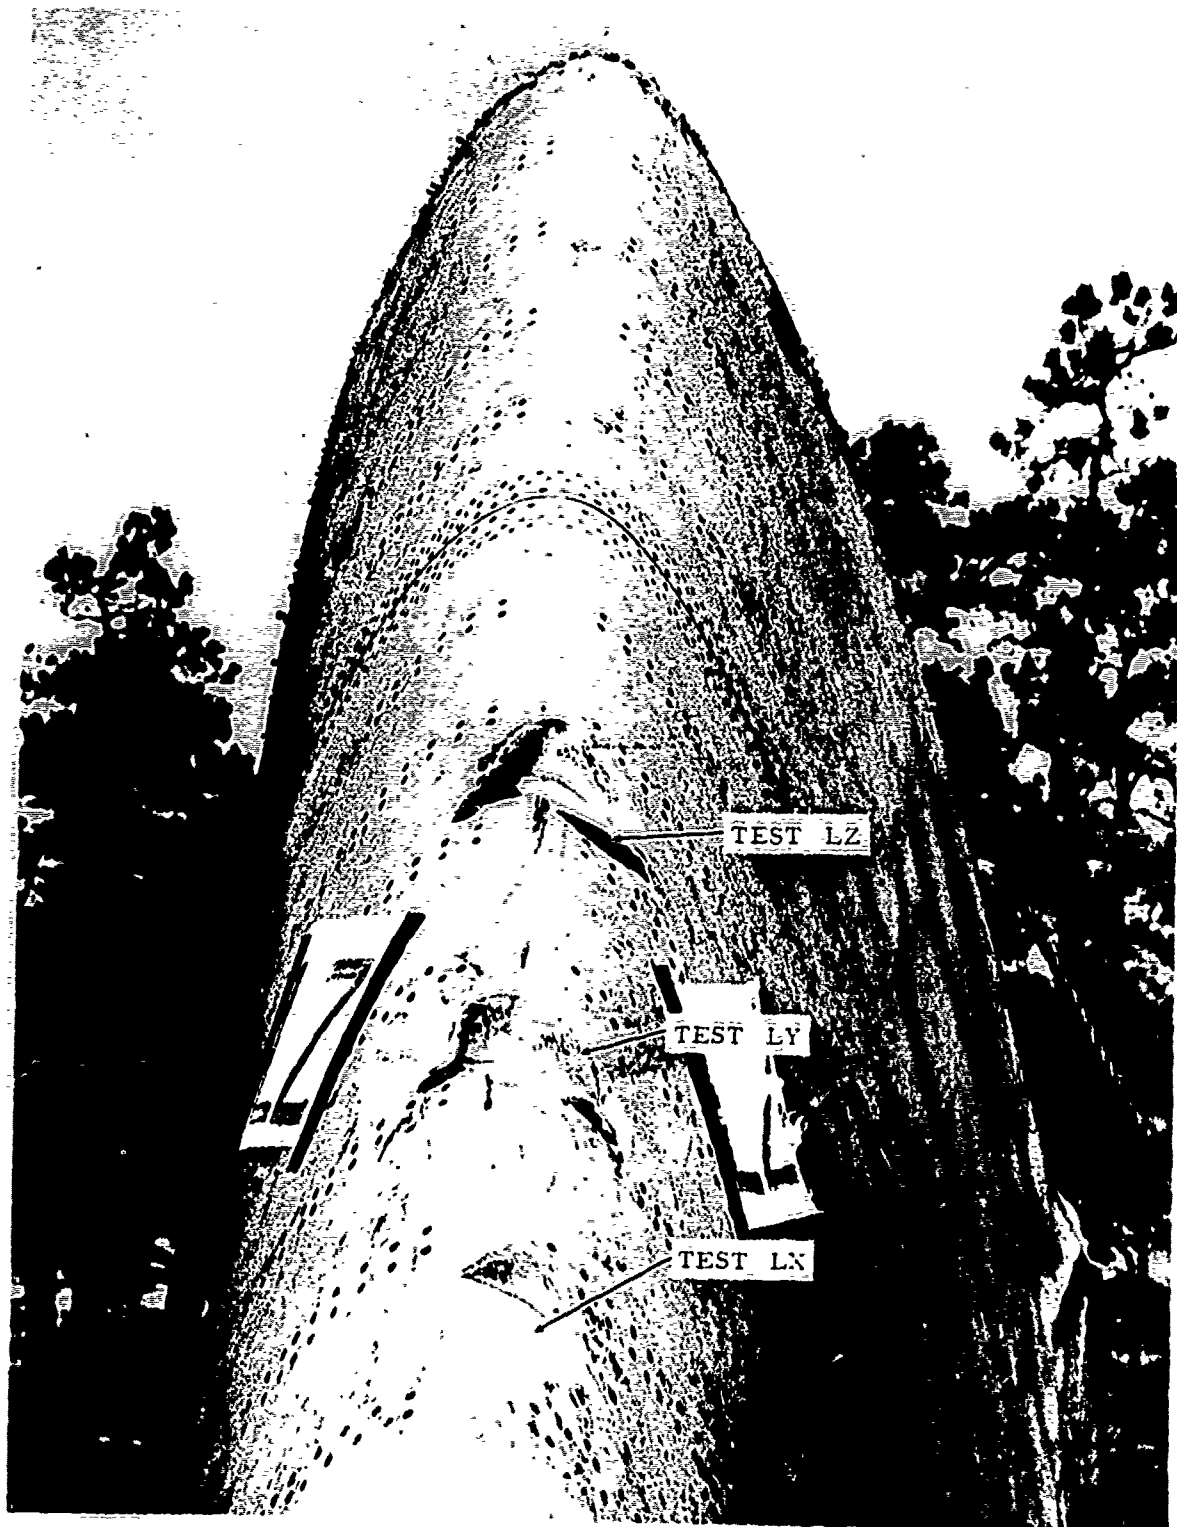
FIGURE 16. DAMAGE TO WING - TEST 7, 8, 9 - ANGLE IRON
